**Official Information Act request: Report into *MV Aratere* Oil Content Meter Tampering Investigation**

# Memorandum

DATE 08 August 2018

OUR REF Aratere OCM

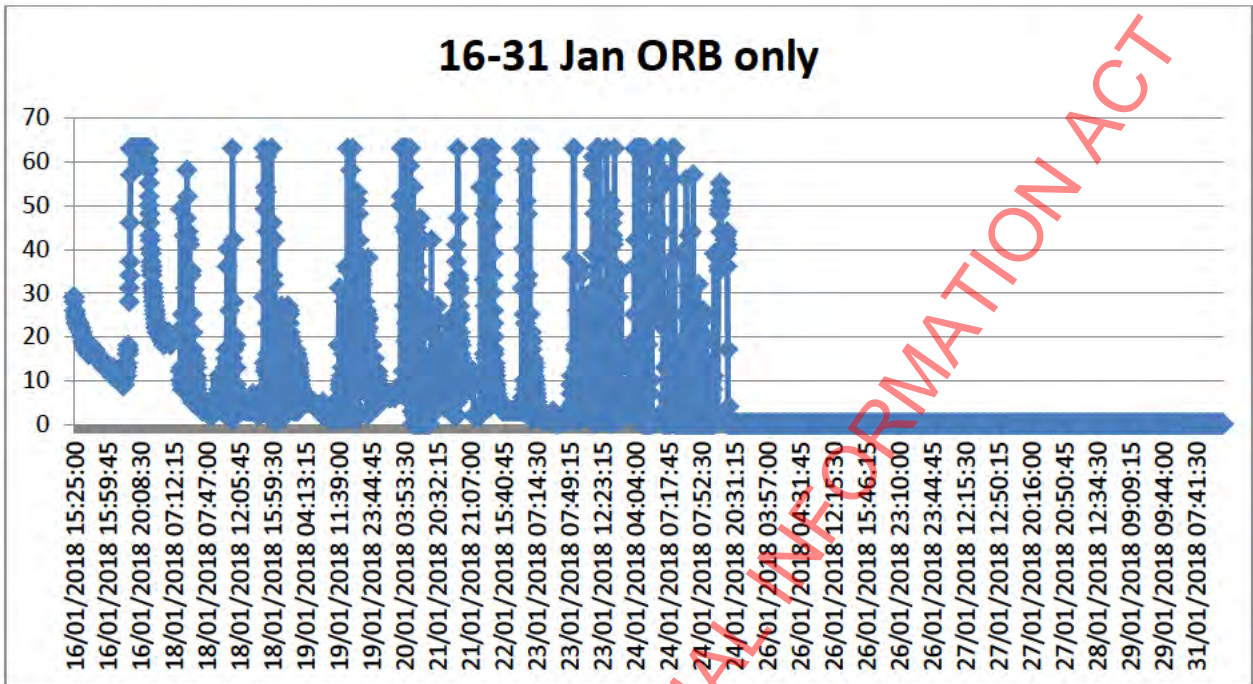
However, there were several occasions when [REDACTED] shift crew also had 0 ppm readings during apparent discharges.

Both shifts had fluctuations, and both had 0 ppm readings, but [redacted] shift had more 0 ppm readings than [redacted] shift.
