Accident Report
Capella Voyager
Grounding in the Approaches to
Whangarei on 16 April 2003

REPORT NO.: 03 3177

VESSEL NAME: CAPELLA VOYAGER

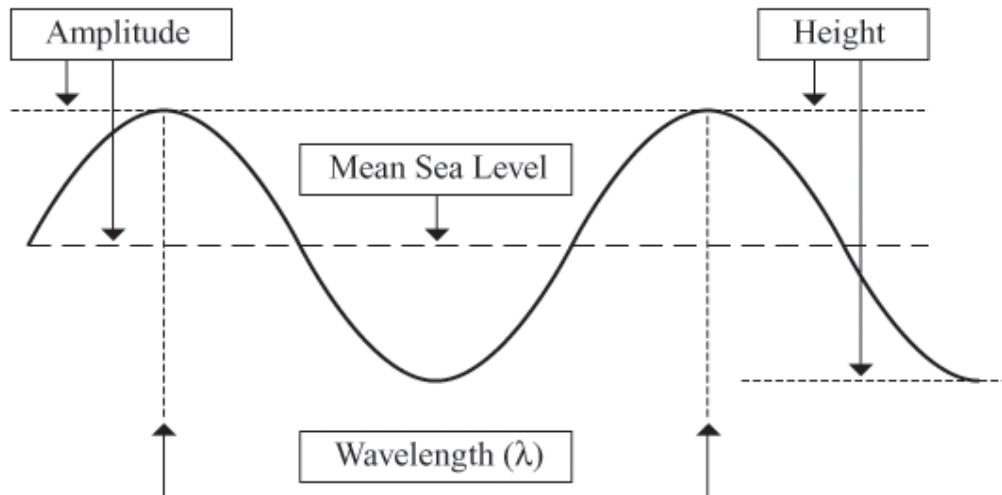
- 2.12.2 Swell is a type of wave which has been propagated outside its generating fetch - it is no longer under active generation. It can be generated by a weather system that can be some distance from where swell conditions may first develop. Other waves that are generated locally are often referred to as 'wind waves'. They can be superimposed onto swells thereby increasing the overall height of the wave, or the vertical distance between the wave's peak and its trough. Other significant measurements of any wave are its wavelength or the horizontal distance between wave peaks, and period (the time between peaks passing a fixed point). In Northern Europe, according to NIWA, a period of more than 10 seconds is the threshold beyond which a wave is defined as being swell. Locally generated waves have a shorter period, and generally do not greatly influence ship motions on large vessels. Swells which have the longer period cause the most significant vessel motions.

- 2.12.3 When any wave encounters a shoaling seabed, its wavelength will decrease, its period will remain the same and its height will increase.
- 2.12.4 There is also a change in velocity which produces a refraction effect, so that waves 'bend' from their initial direction towards the direction in which the shoaling occurs. In this instance, the shoaling was broadly to the north east of the general swell direction, so the waves would have tended to refract slightly in that direction.
