Accident Report

Unnamed Yacht

Beaching - 10 Miles north of
Napier on 18 January 2005

REPORT NO.: 05 1162

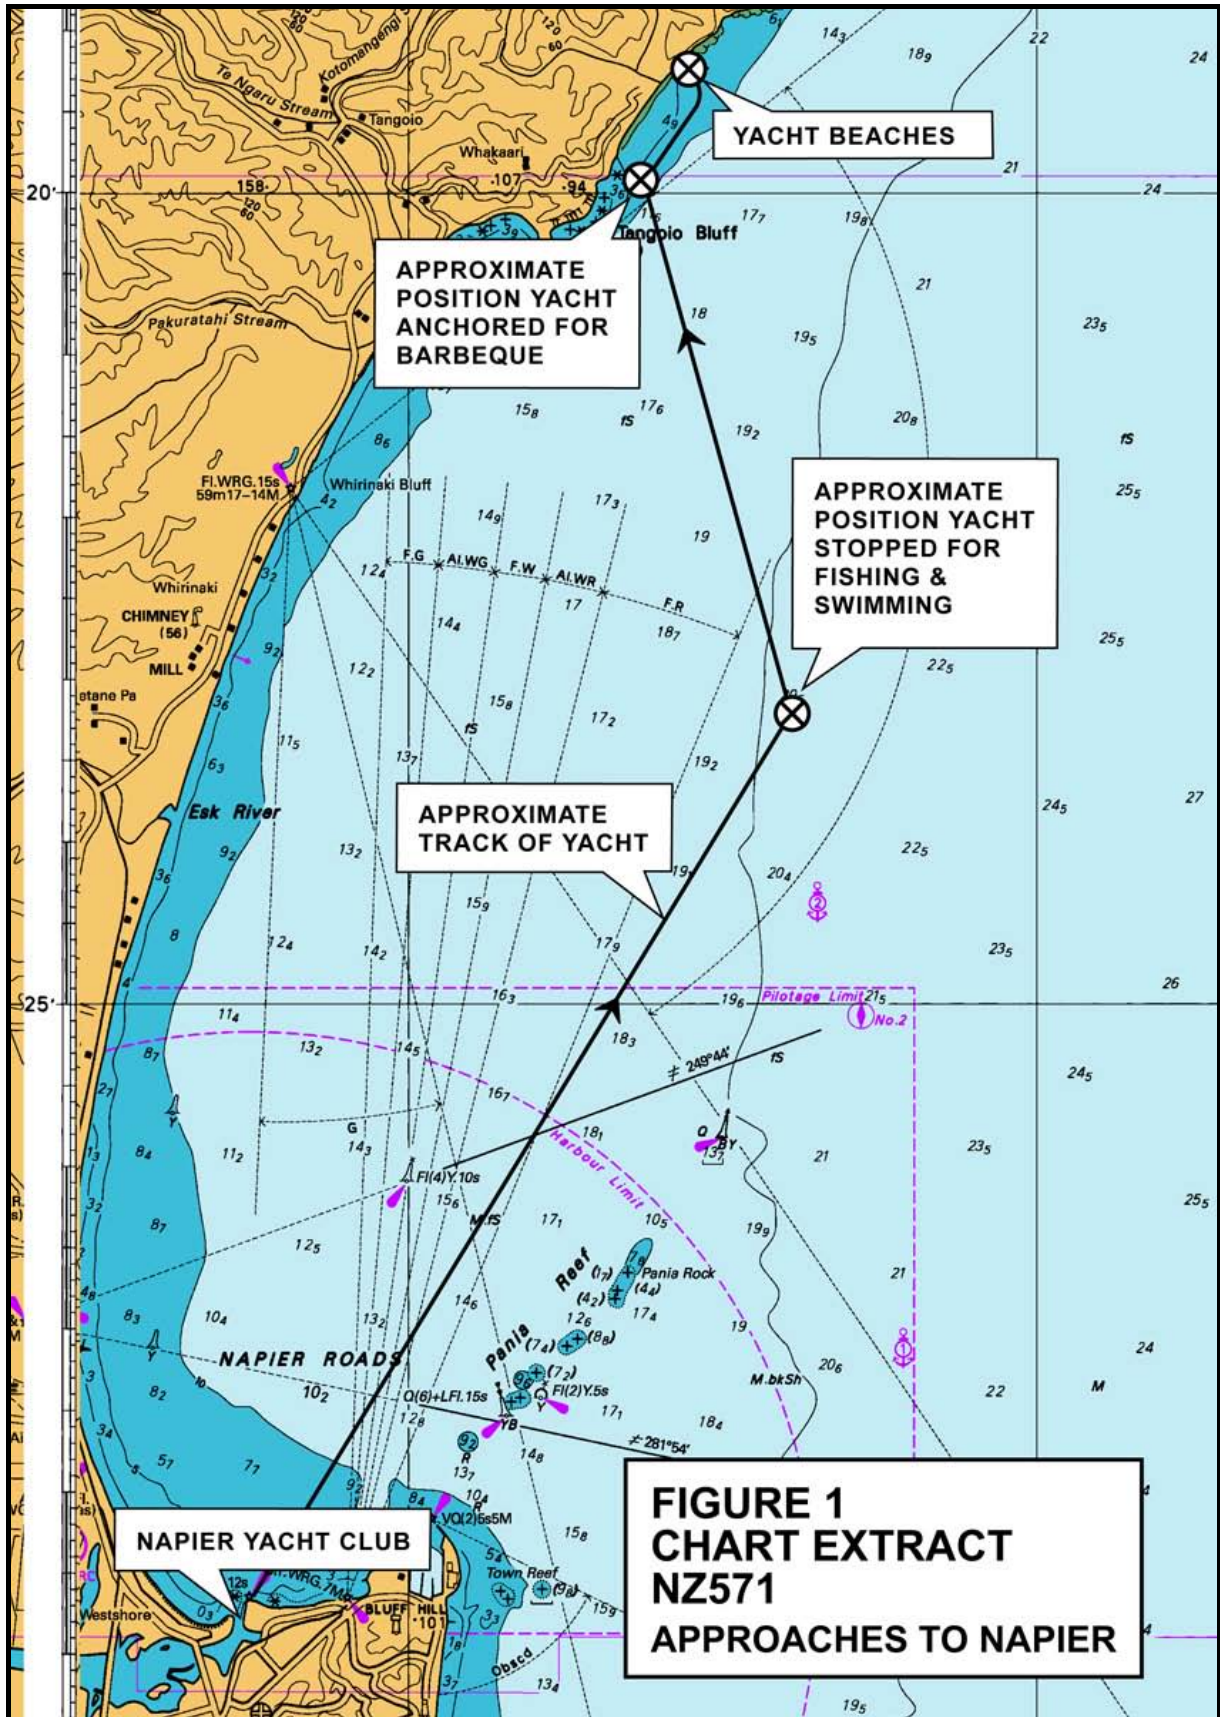
Figure 1 – Chart Extract NZ571 – Approaches to Napier

The Skipper, along with his friends, left home about 1100 hours to tow the trailer sailer to Napier Yacht Club. They filled up the petrol tank then launched the yacht, using the yacht club tractor, at about midday. They motored north across the bay, passing the yellow special purposes buoy, with the intention of stopping and drifting for a barbeque lunch. (See Figure 1 - Chart Extract NZ 571, Approaches to Napier).
